# HIGH-PERFORMANCE REFRACTORY

## Increased Run Time of Spent Wash Boiler Operations

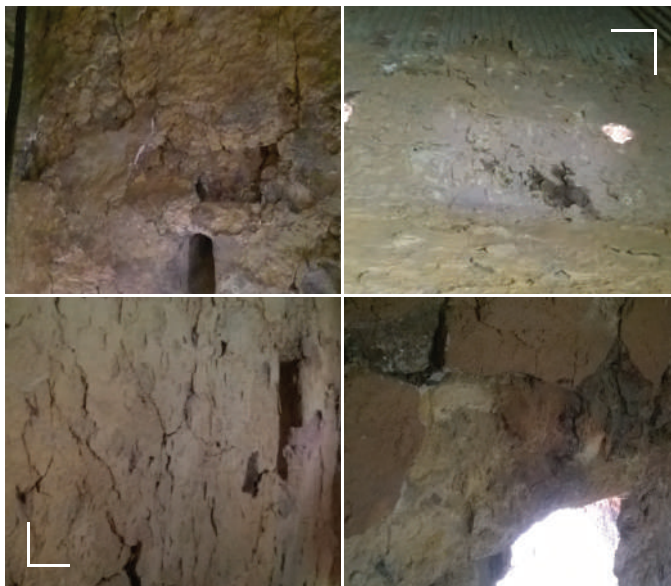
- Performance related issues: spalling, erosion, infiltration of spent liquor inside the refractory lining.

Pictures from the sugar plant displaying non-Calderys refractories.

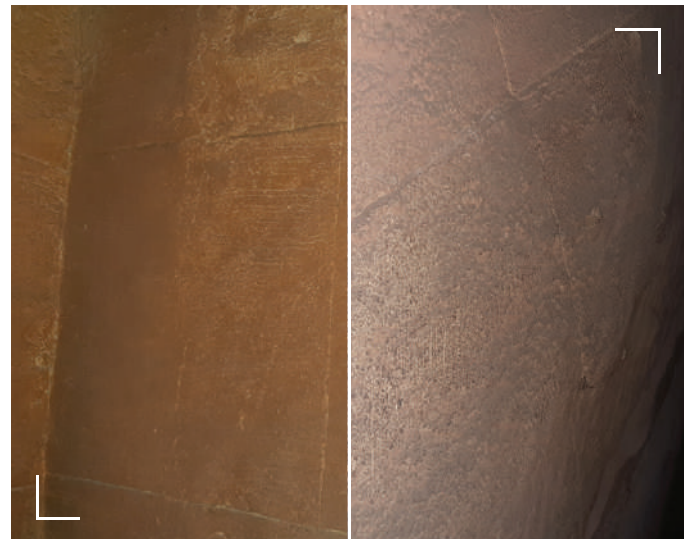
The refractory solution provided by Calderys shows no erosion in refractories even after 10 months of operation, as seen below:

After 4 Months

After 10 Months

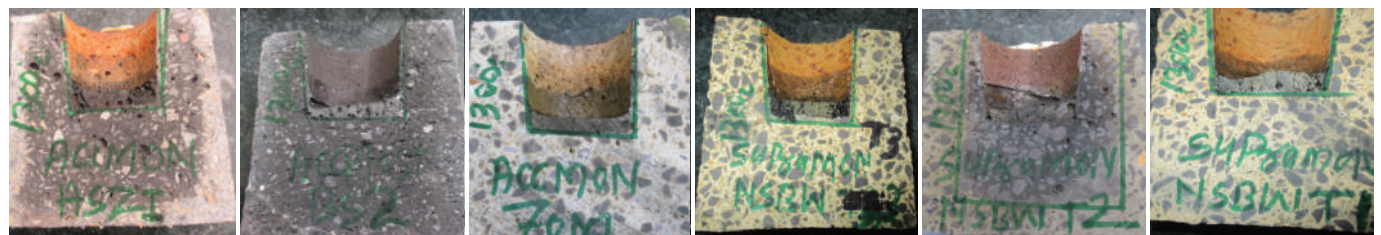
Cut texture of different qualities after test:

ACCMON ASZI

ACEPLAST RAM BS2

ACCMON 70 M

Supramon MRZ (Trial)

Supramon MS (Trial)

Supramon MR(Trial)

Interaction was found negligible in all the six samples, but ACEPLAST RAM BS2 was the best after 5 hours interaction at 1300° C.

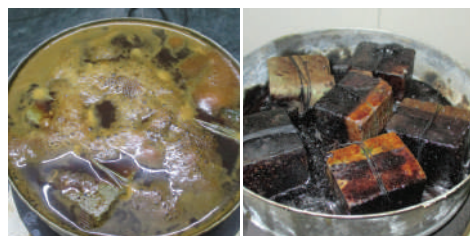
3. Small pieces (500°C for 3 hours) of all the qualities were dipped in the spent wash liquid (for 1 day):

pieces were kept in Spent Wash Liquid at 100°C (hot Plate)

Samples after liquid evaporation.

**Observations:** ACEPLAST RAM BS2 was least affected even after exposure to liquid for a day.

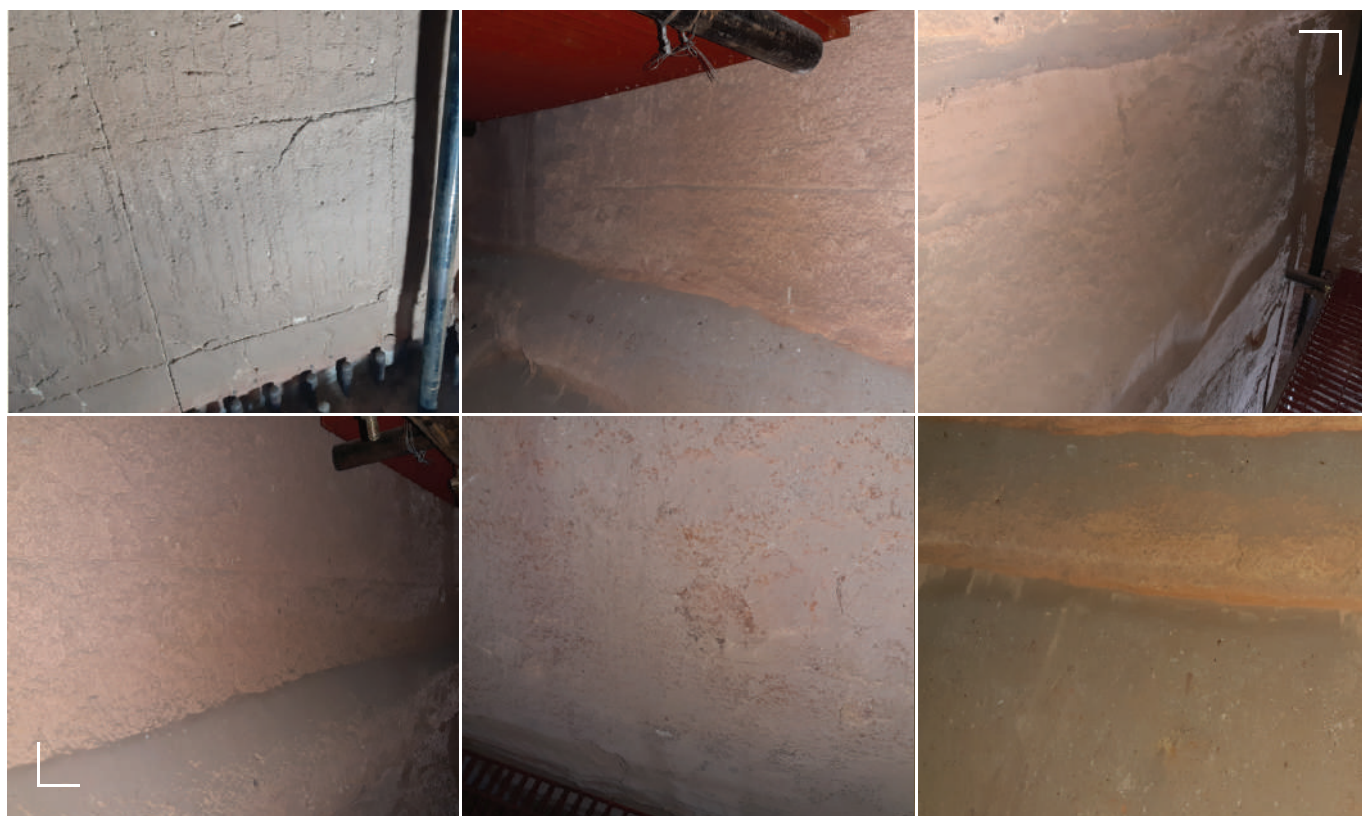
- ACE PLAST RAM BS2 Plastic refractory applied in hot face lining in spent wash Boiler of M/s. thermax at M/s. Jaywant Sugar site, Satara (Maharashtra)
- The refractory lining met its performance objective

After 8 Months of Boiler operations  
(200 days of continuous operation with spent liquor) - November 2019
